# RESTORATION AND MANAGEMENT OF RIVER FLOODPLAINS: EXPERIENCE OF THE LIFE+ PROJECT DVIETE

Project No LIFE09 NAT/LV/000237  
Restoration of Corncrake habitats in Dviete floodplain Natura 2000 site  
2010-2015

Publication prepared within the project LIFE09 NAT/LV/000237  
'Restoration of Corncrake habitats in Dviete floodplain Natura  
2000 site' (acronym – LIFE+ project DVIETE)

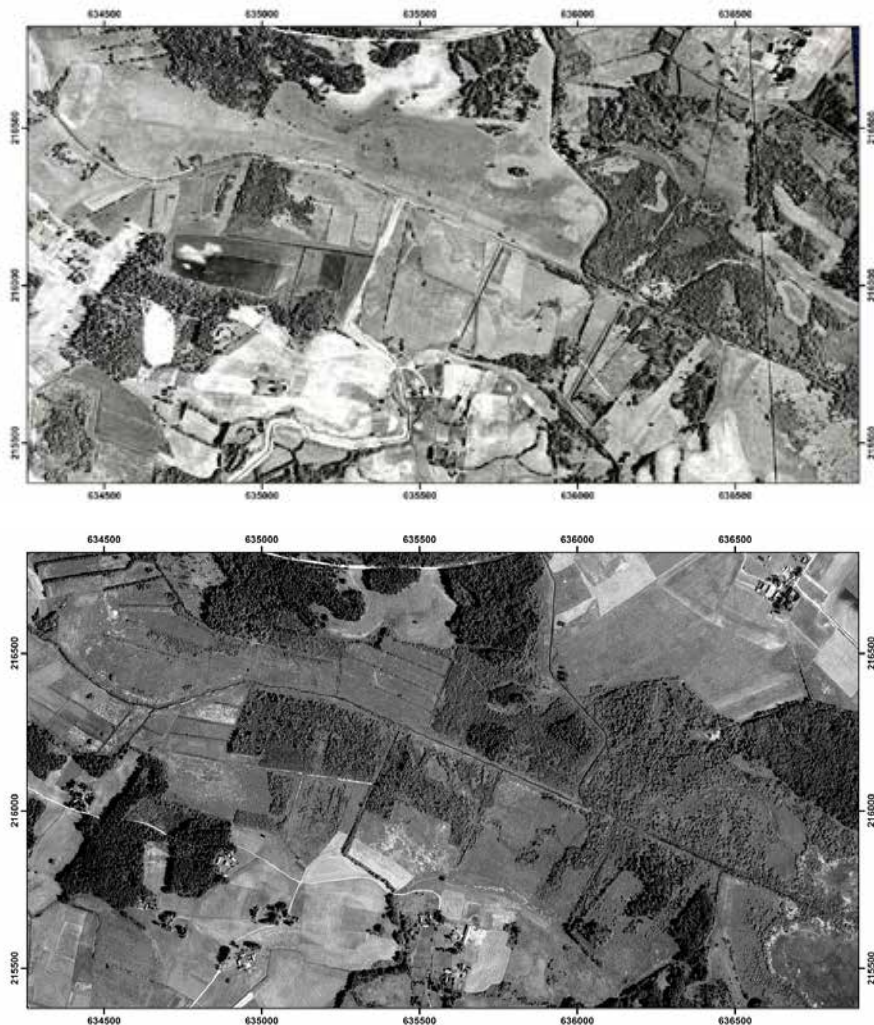
Figure 3. The LIFE+ project DVIETE territory in 1963 and in 2005 (© LĢIA).

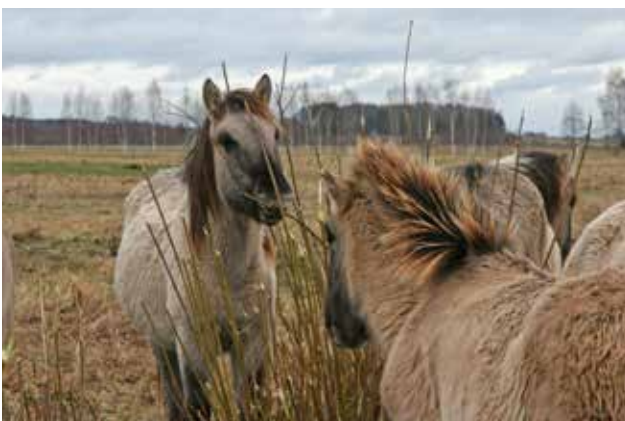
**Figure 7.** 'Konik' horses browsing bush bark and the tops of outgrowth (29.11.2013). Photo: I. Priedniece

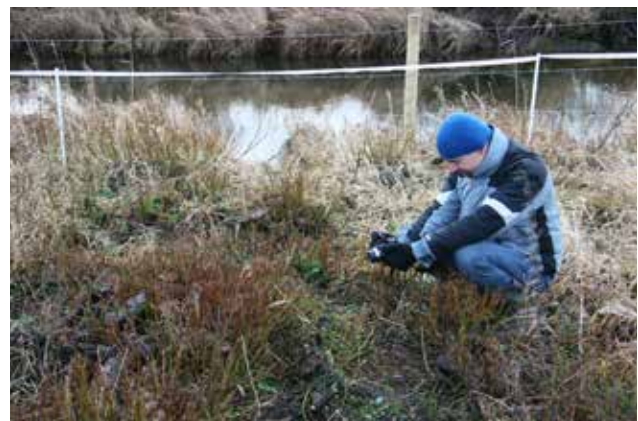
**Figure 8.** Grazing animals' browsed bush outgrowth (29.11.2013) in a location where in the previous winter bushes were cut. Photo: I. Priedniece

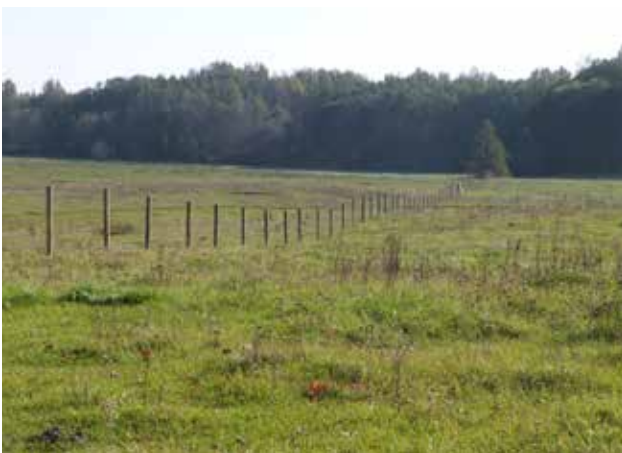
**Figure 9.** The internal fence that diverts animals to less browsed areas in the summer (03.10.2014). Photo: B. Štrausa

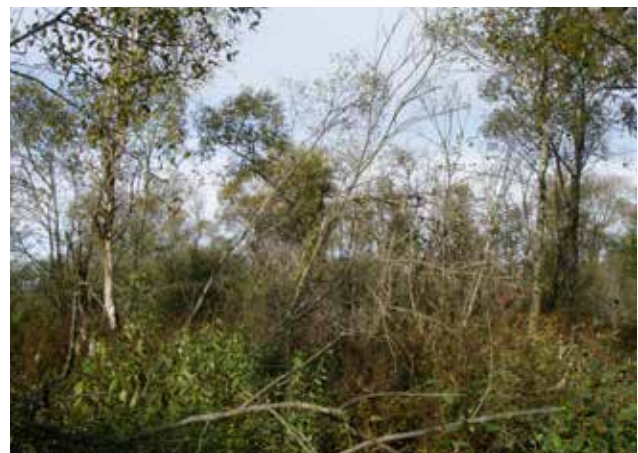
**Figure 10.** Shrubbery in the Dviete floodplain before grassland renewal (10.10.2007). Photo: E. Račinskis

In the project it was planned to gradually remove bushes and trees from 105 ha of overgrown (Figure 10), previously open floodplain. This, together with the existing meadows and pasture fragments would create approximately 300 ha of open, Corncrake suitable grasslands.

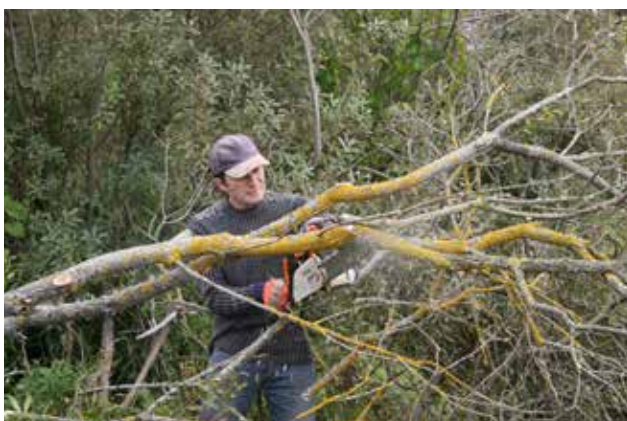
**Figure 12.** Cutting of bushes in overgrown Dviete floodplain meadows (22.09.2012). Photo: I. Priedniece

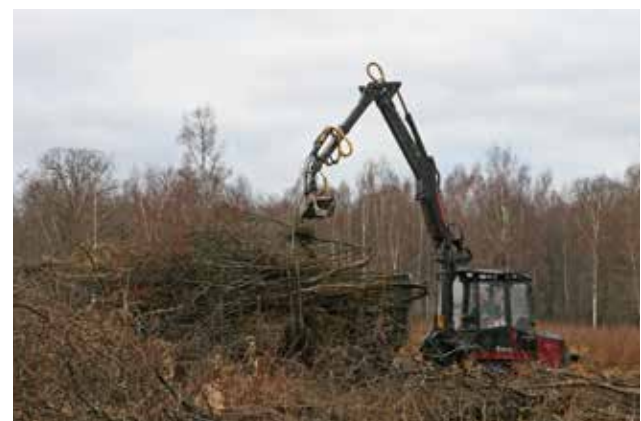
**Figure 13.** Removing the cut bushes from the Dviete floodplain (29.11.2013). Photo: I. Priedniece

In places that tractors could access, the cut bushes and trees were removed from the floodplain, in non-accessible sites they were burned.

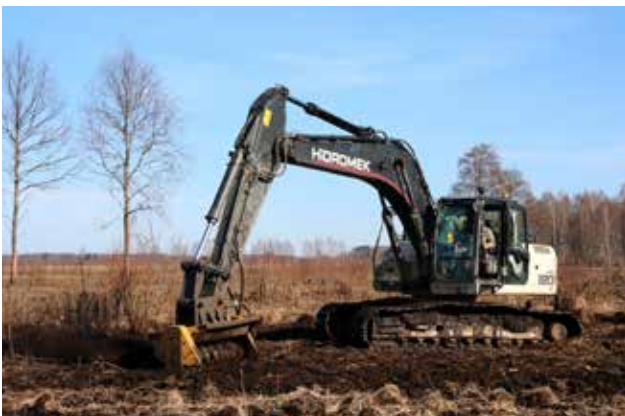
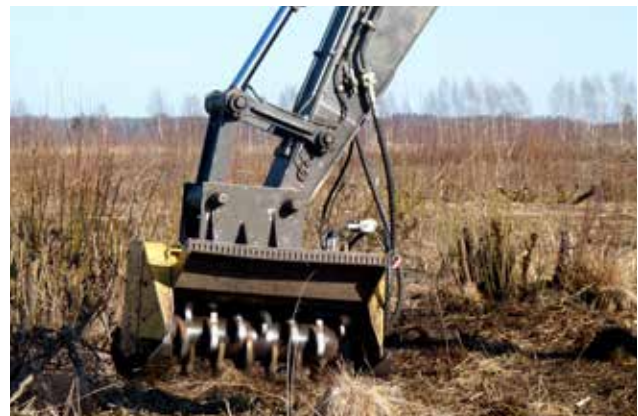
Figure 16 and 17. Stump mulching equipment at work (13.03.2014). Photo: I. Priedniece, E. Račinskis

was performed with special equipment (Figure 16 and 17). The mulching was planned for approximately 50 ha.

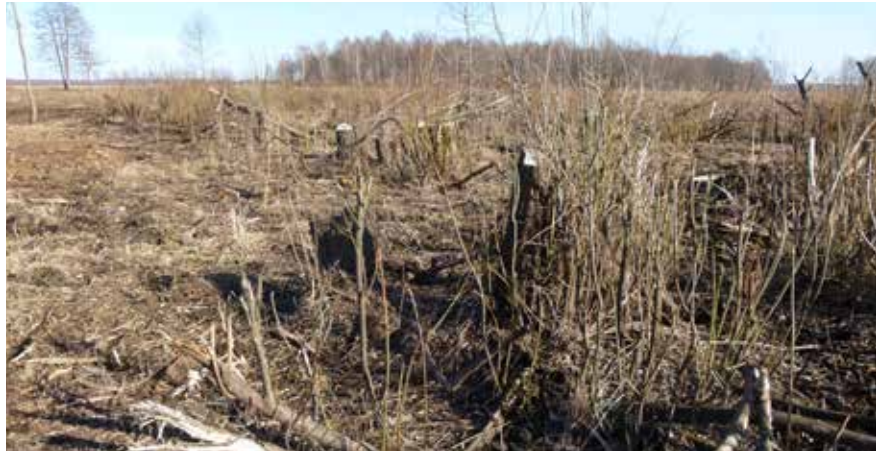
Figure 18. The floodplain area with tall tree and bush stumps and outgrowth before mulching (13.03.2014). Photo: E. Račinskis

A local company was hired to do the work and the necessary equipment was purchased. The mulching was performed in two winter seasons. At the end of the 2013/14 winter, 14 ha were mulched in an area which the previous winter was covered by a thick sheet of ice, because of which tall bush and tree stumps remained (Figure 18). In the winter of 2014/15 the mulching increased in volume (39.7 ha) for a total of 53.7 ha (Figure 19 and 20).

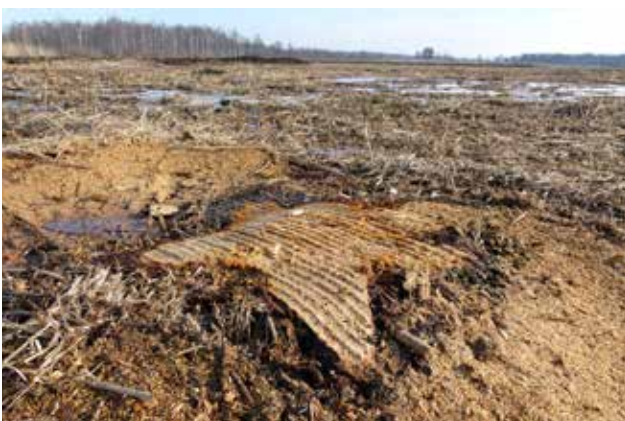
Figure 20. Mulched area immediately following the mulching (20.02.2015). Photo: E. Račinskis

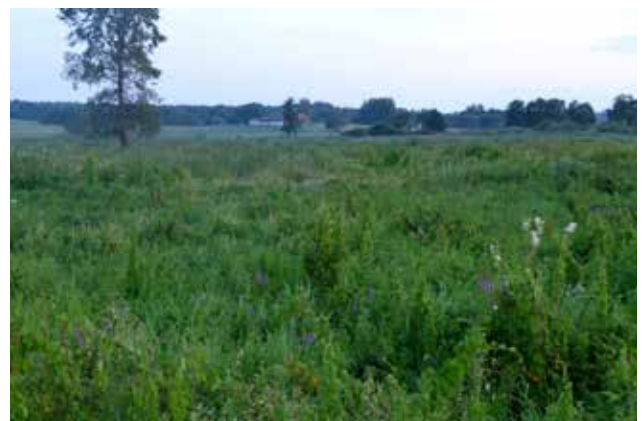
Figure 21. The mulched area in the summer after the work was performed (24.07.2014). Photo: E. Račinskis

This activity produced very good results – most of the trees and bushes died off and outgrowth either didn't happen at all or was minimal (Figure 21). The results of the mulching work lasted for an entire year and in the autumn the area was accessible to mowing equipment.

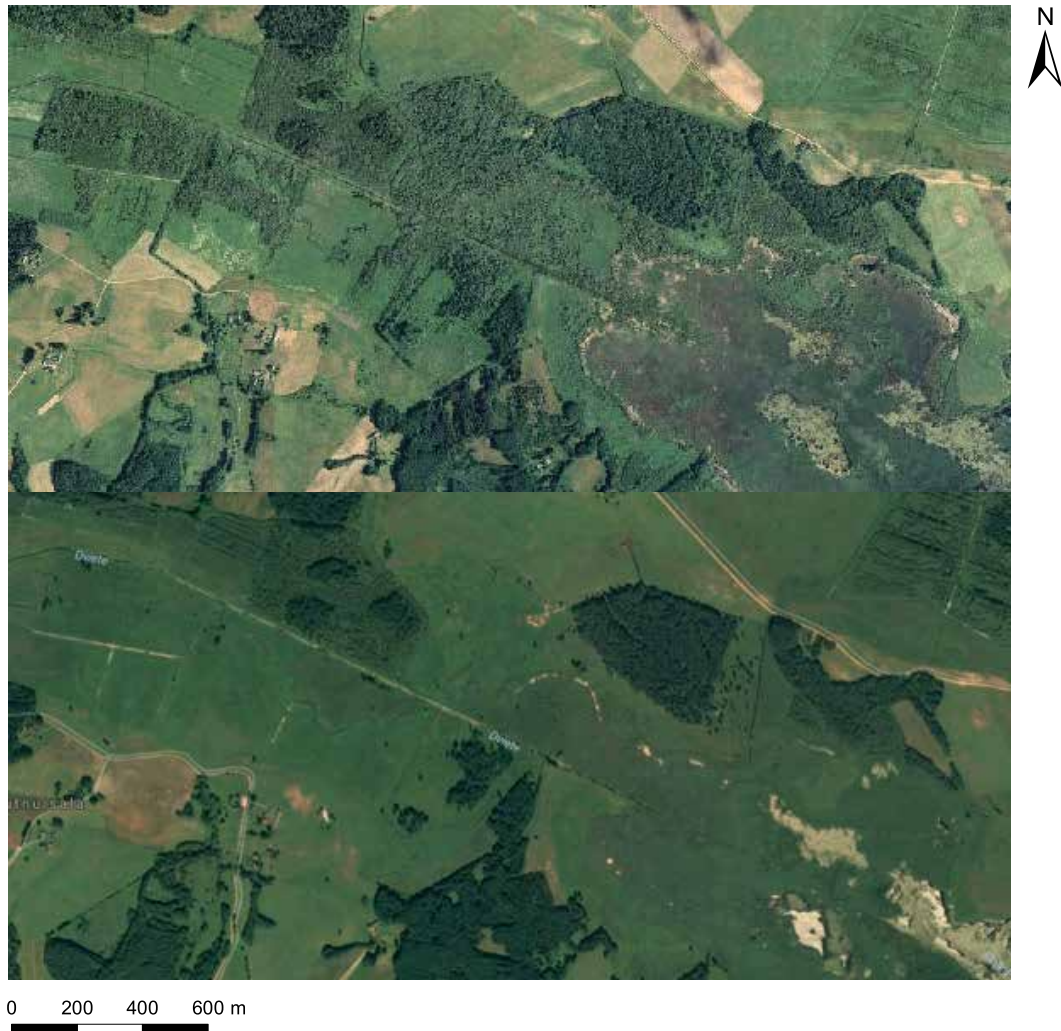
**Figure 22.** The LIFE+ project DVIETE area before (2005) and after (2014) grassland restoration within the project. Map data: © 2005 LĢIA, © 2014 Google

The grassland restoration activities performed during the project, as a whole, have significantly altered the landscape of the middle part of the Dviete floodplain nature park (Figure 22, 23, 24 and 25).

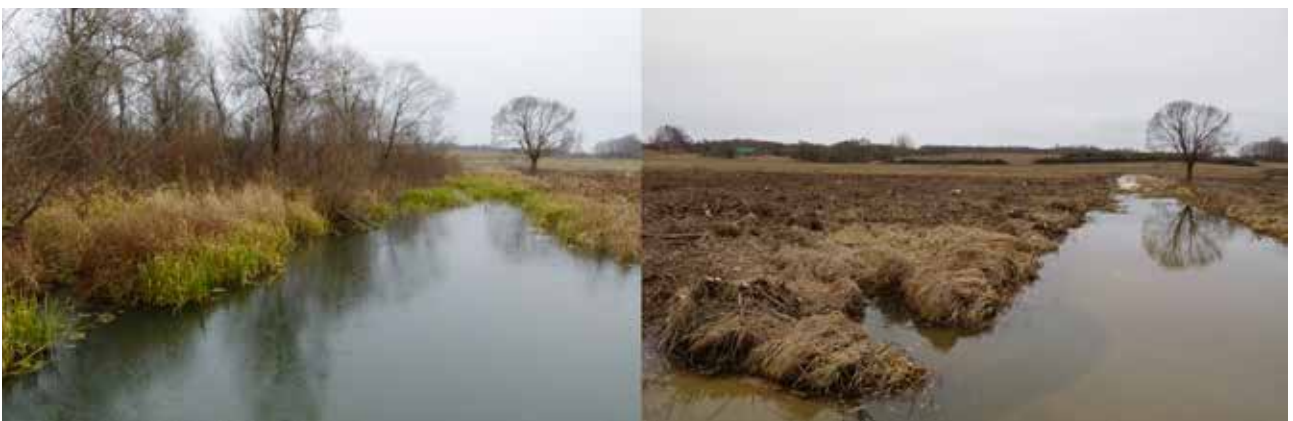
**Figure 23.** The Dviete floodplain landscape before and after grassland restoration (11.11.2011 and 21.03.2012). Photo: E. Račinskis

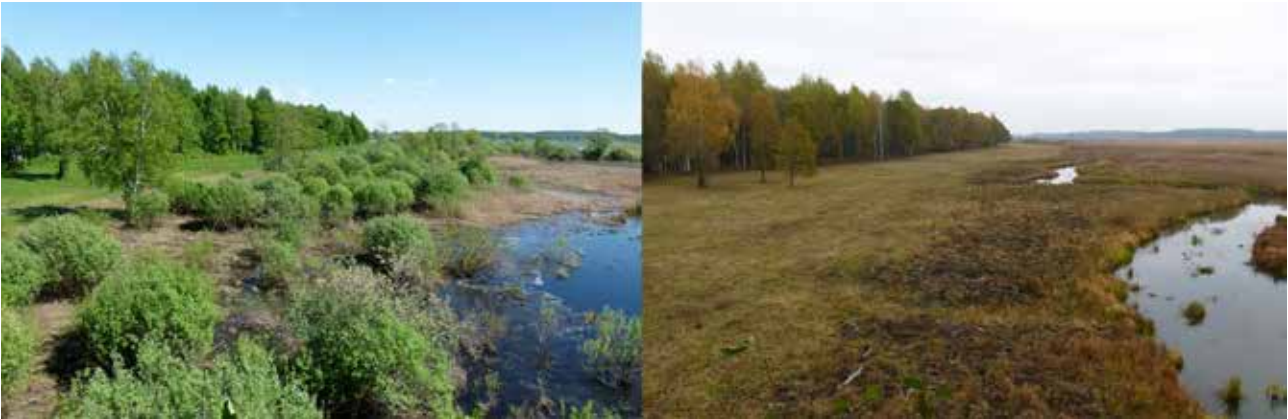
Figure 24. The Dviete floodplain landscape before and after grassland restoration (24.05.2011 and 22.10.2015). Photo: E. Račinskis

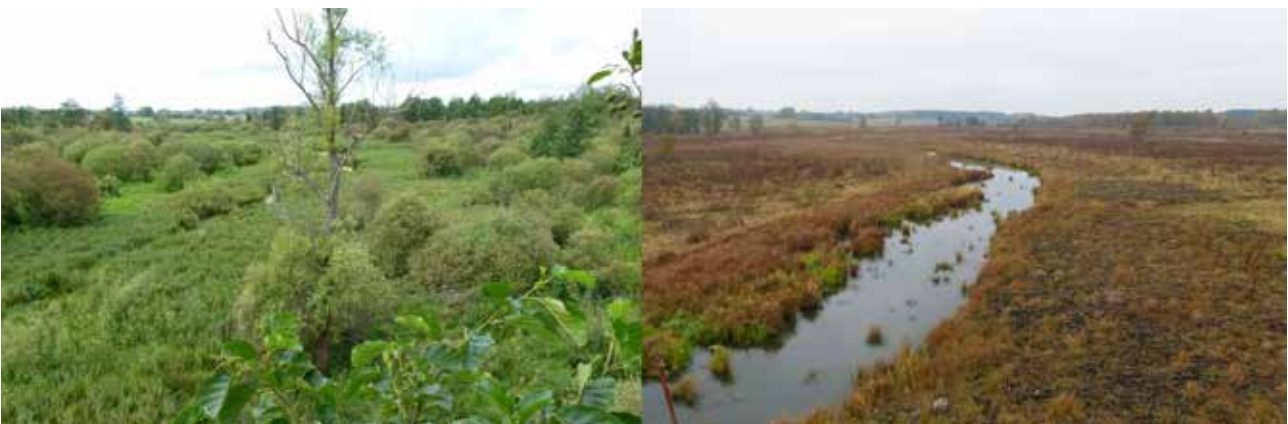
Figure 25. The Dviete floodplain landscape before and after grassland restoration (09.08.2012 and 22.10.2015). Photo: E. Račinskis

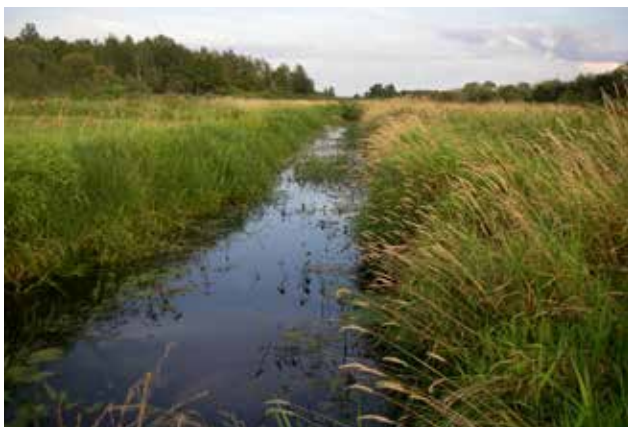
**Figure 6.** Channelised Dviete River (19.08.2007).  
Photo: E. Račinskis

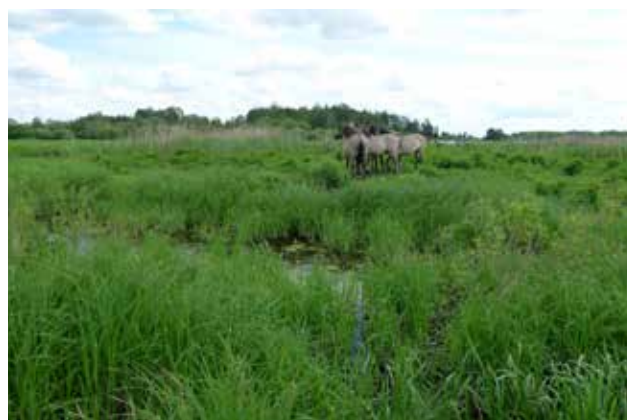
**Figure 7.** Old riverbed of Dviete before restoration (14.06.2012).  
Photo: E. Račinskis

natural riverbeds of channelized rivers, enlargement of the water capacity of the floodplain during floods, reducing the draining of Skuķu and Dviete lakes during the low-water period and suppressing the overgrowth of the floodplain (Račinskis 2008). The section of the Dviete River above Skuķu lake was chosen as a priority of the restoration (Figures 5 and 6). It was the upstream section of the Dviete within the nature park, where historical meanders of the river existed in the field as oxbow lakes (Račinskis 2008; Fig. 7).

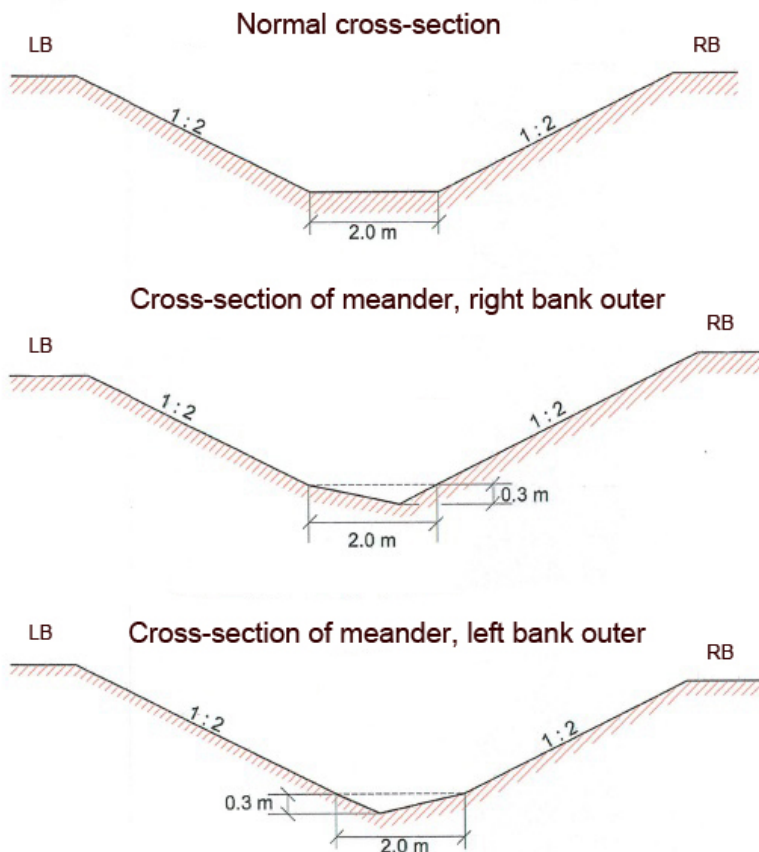
Figure 12. Cross-sections of the riverbed, planned by “Meliorprojekts” State Ltd. LB – left bank, RB – right bank.

A solution for the main issue was reached within this version of the technical project – the restored riverbed would not have a draining effect on the river floodplain. Still we did not succeed in integrating diverse cross-sections, as proposed by the Dutch experts, in the technical project (Fig. 12.), nevertheless it was also recommended by PAIC. Further renaturalization of the meandering riverbed after hydro-technical work by the project were left to natural processes.

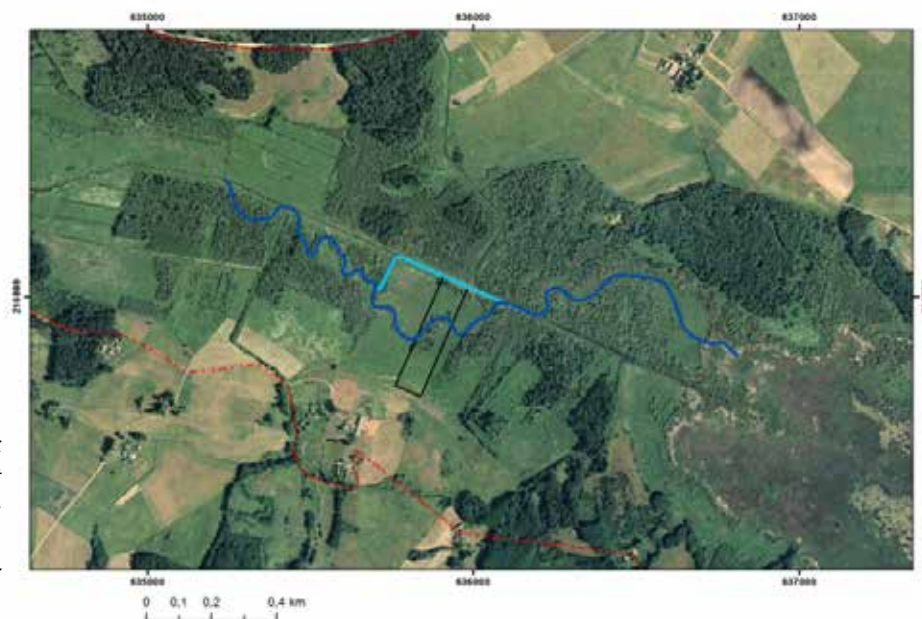
**Figure 13.** Dviete River section, initially planned for restoration (dark blue) and the section, left straight (light blue) due to objections by the owner of the land parcel (black line). Orto-photo (LĢIA 2005) is used for background.

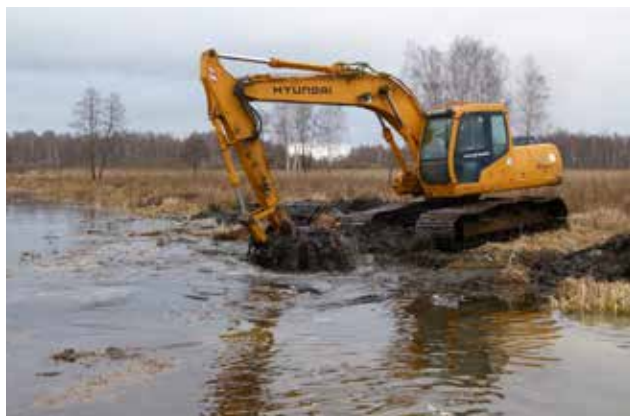
**Figure 14.** Removal of a beaver dam to decrease the water level for engineering work (14.01.2015). Photo: E. Račinskis

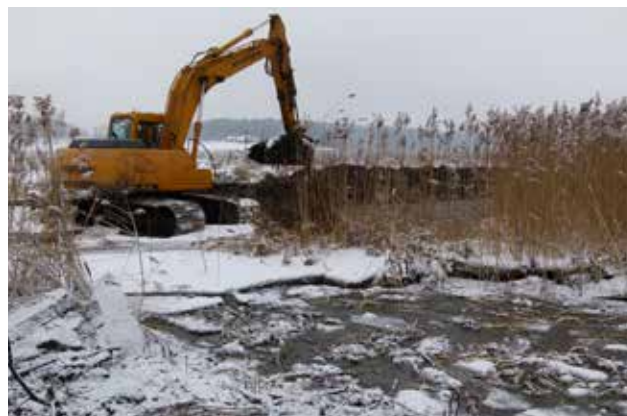
**Figure 15.** River restoration was carried out in winter in order to harm nature as little as possible and to ease working with the excavator in the sloughy floodplain (23.01.2015). Photo: E. Račinskis

DVIETE took place on 5 December. Engineering work only started in the second half of January, because the Dviete floodplain was flooded from the middle of December 2014 till the middle of January 2015 due to a rapid melting of snow and an extended rainy period. At the beginning of the engineering work, the floodplain was still lightly flooded. To decrease the water level, beaver dams on the river and an inflowing ditch were removed (Fig. 14). Deepening of the old riverbed with a small and comparatively light excavator on wide caterpillars (Figures 15–18) started on 22 January and continued until the end of March.

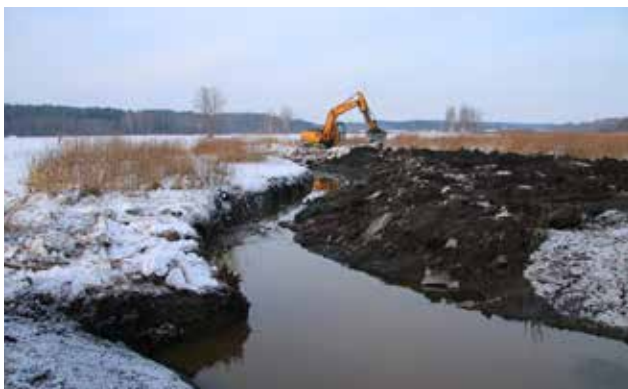
Figure 16. Excavation was performed mainly from both banks of the old riverbed (30.01.2015; picture shows a half of the river's width excavated). Photo: I. Priedniece

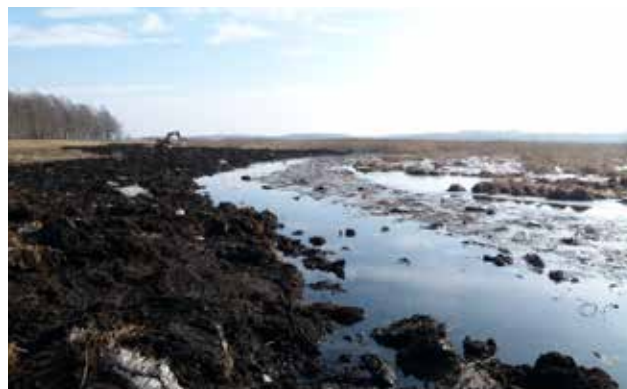
Figure 17. In most sloughy sites at the inflow of the Dviete River into Skuķu lake, the deepening of oxbow was possible only from one bank (20.02.2015). Photo: E. Račinskis

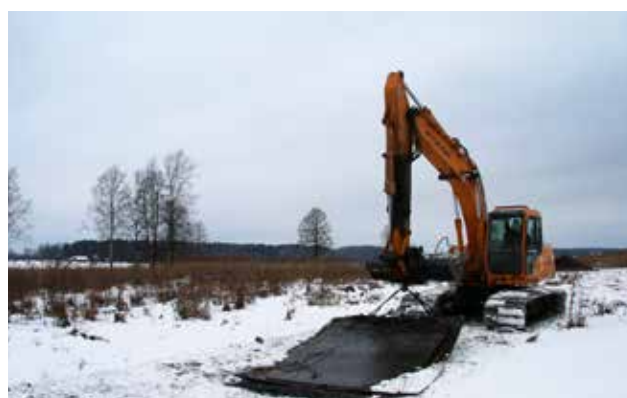
Figure 18. In most sloughy sites metal plates were put under the caterpillars of the excavator (29.01.2015). Photo: I. Priedniece

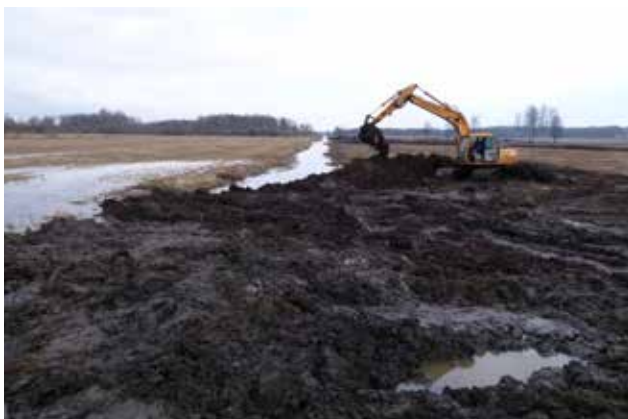
Figure 21. Construction of the first dam at the upper part of the restored section (05.03.2015). Photo: E. Račinskis

Afterwards, till the end of March 2015, three dams on the straightened riverbed were built to redirect the stream in the restored historical bed, another threshold was arranged on the upper part of the unrestored section of the old riverbed (Figures 19–24.). A ford for agricultural machinery was also built on the restored riverbed (Figures 19, 25, 26). After completion of the dams, the upper parts of the restored meanders were connected to the existing river, and the stream of the Dviete River began to flow through them after about 80 years (Fig. 20).

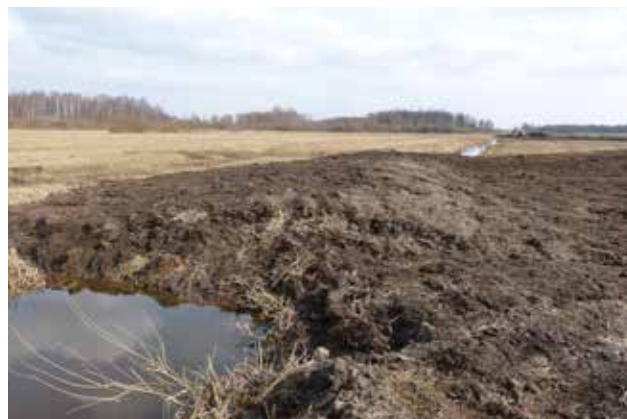
Figure 22. The first dam at the upper part of the restored section completed (25.03.2015). Photo: E. Račinskis

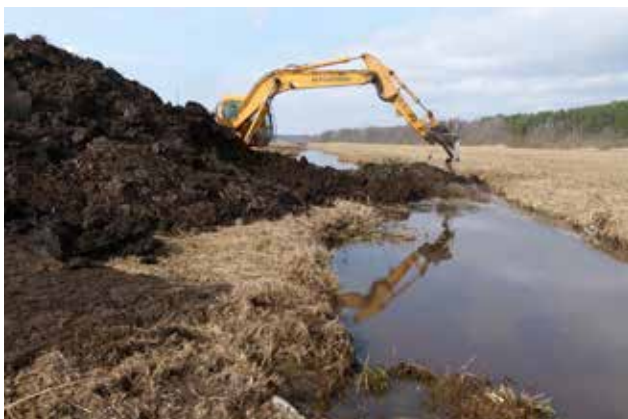
Figure 23. Construction of the second dam on the straightened riverbed (25.03.2015). Photo: E. Račinskis

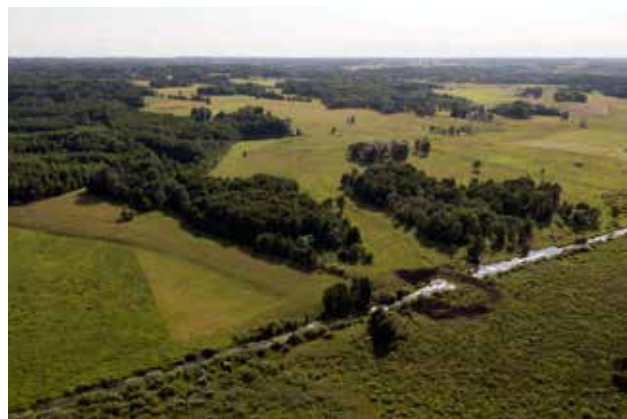
Figure 24. A view of the third dam from above (16.07.2015). Photo: Elm Media

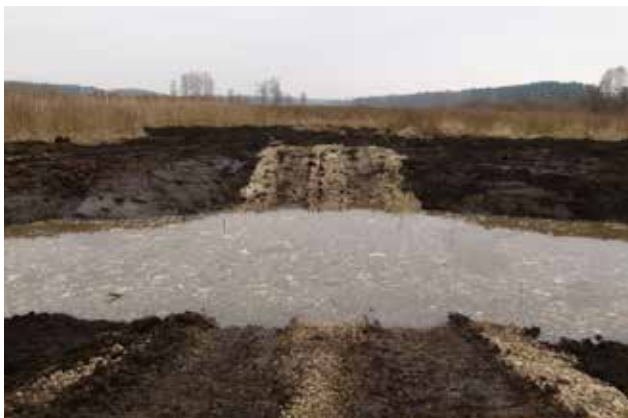
Figure 25. Ford arranged for crossing the river by agricultural machinery (25.03.2015).

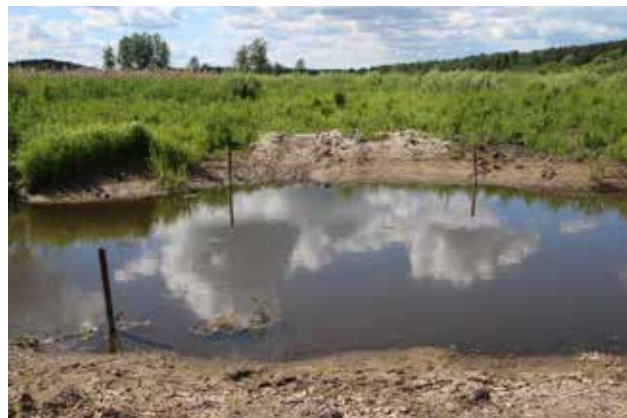
Figure 26. The ford in summer 2015 (16.06.2015).  
Photo: I. Priedniece

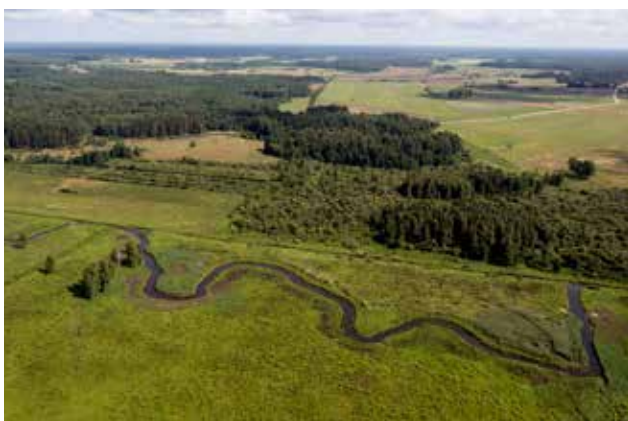
Figure 27. Dviete River meanders in the upper part of the restored section (16.07.2015). Photo: Elm Media

After the restoration of the Dviete River section above Skuķu lake, the landscape of the floodplain has changed considerably. The river has partly returned to its historical meanders (Figures 27 and 28), and in complex with open grassland areas restored within the LIFE+ project DVIETE, somewhat resembling its state at the beginning of the 20th century, when the floodplain was used for traditional agriculture – mowing and grazing.

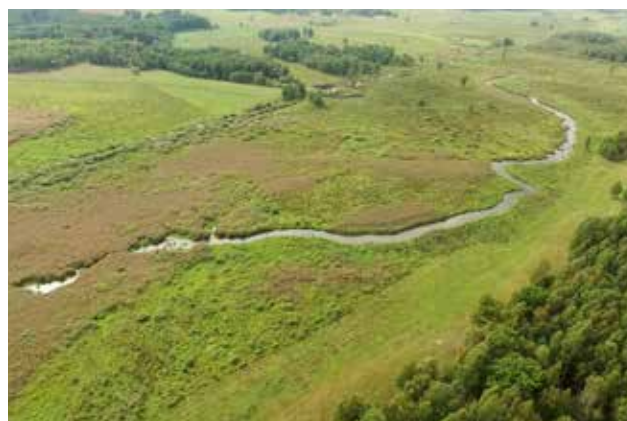
Figure 28. Dviete River meanders in the lower part of restored section (15.09.2015). Photo: Elm Media

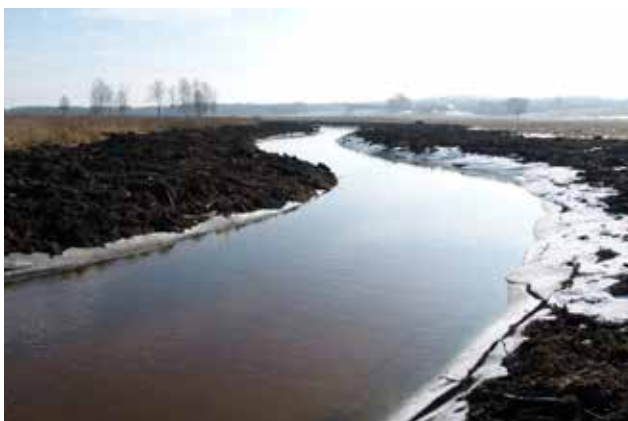
**Figure 29.** The restored Dviete River soon after excavation (20.02.2015). Photo: E. Račinskis

landscape (Figures 29 and 30). The next years' spring floods and new vegetation seasons will further promote the smoothening of spoil deposit zones and naturalization.

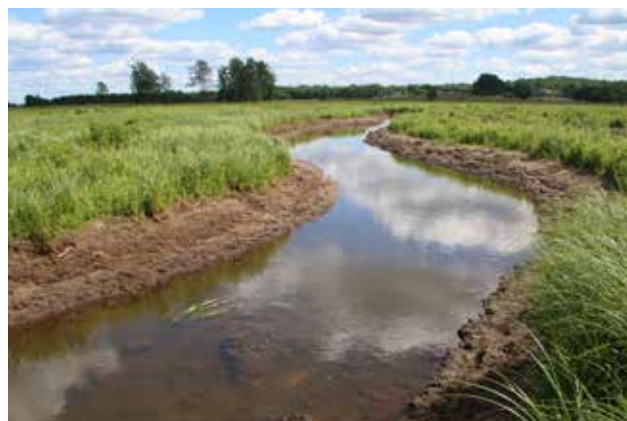
**Figure 30.** The Dviete River 4 months after restoration with overgrown spoil deposit zones (16.06.2015). Photo I. Priedniece

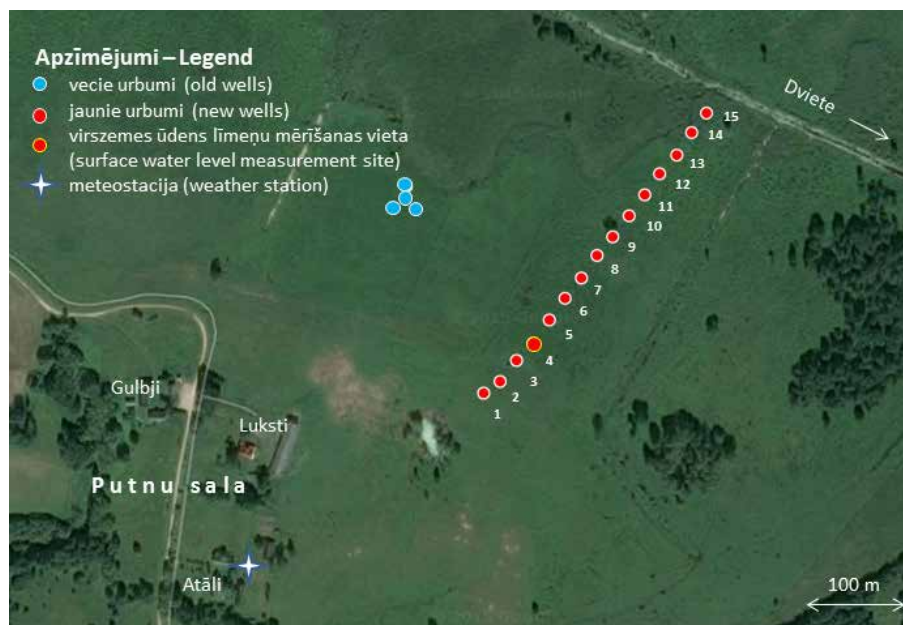
Figure 2. Location of the groundwater level monitoring wells in the Dviete floodplain (map data © 2015 Google)

To assess the possible impact of the Dviete River restoration measures on the floodplain biotopes and groundwater levels, 15 new monitoring wells were established nearby in 2012. They were located about 100 m away from the above mentioned wells to the East-Southeast and lined in a straight transect that is perpendicular to the Dviete River channel. The wells were drilled at regular intervals 20 m apart from each other. The transect line crosses the right side of the floodplain area of the Dviete River, up to its natural border at the foothills of the Putnusala hill (Fig. 2, 3).

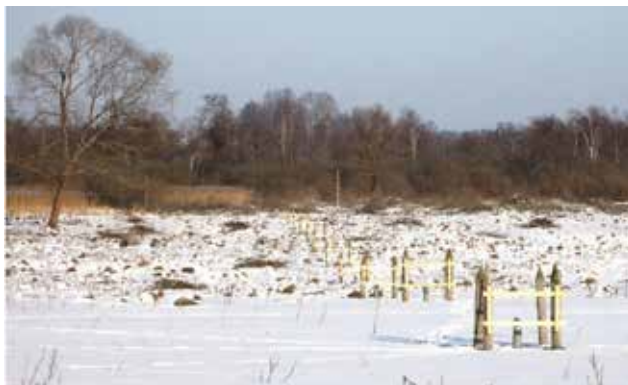
The new monitoring wells were also constructed from plastic tubes 2 m in length and 110 mm in diameter, which were additionally fixed by metallic sticks at a depth of 0.7 m in order to reduce their vertical movement under the pressure of the ice cover.

**Figure 3.** The new groundwater monitoring wells in January 2012 (Photo: D. Gruberts)

Besides, they were also fenced-in to preserve their top ends from the impact of the grazing animals that are located here (Fig. 3).

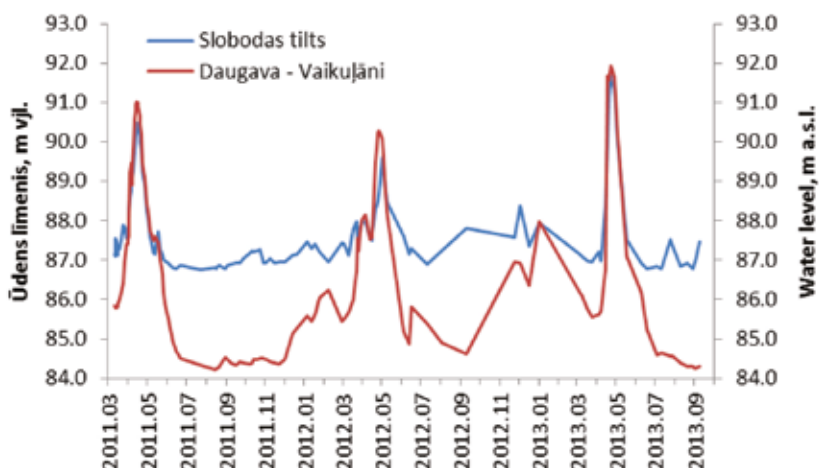
Figure 5. Water level variation at the Dviete floodplain and the Daugava River at Vaikuļāni, 2011–2013 (after unpubl. data of Ā. Gruberte and the Latvian Environment, Geology and Meteorology Centre)

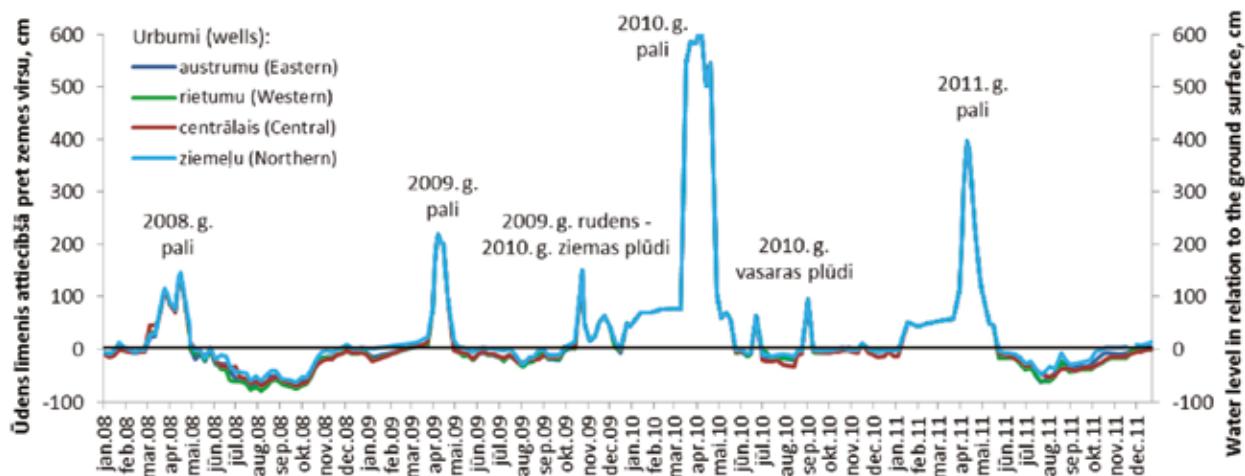
Figure 8. Changes in the relative water level at the old monitoring wells, 2007–2011 (after A. Kriškijāne unpubl. data)

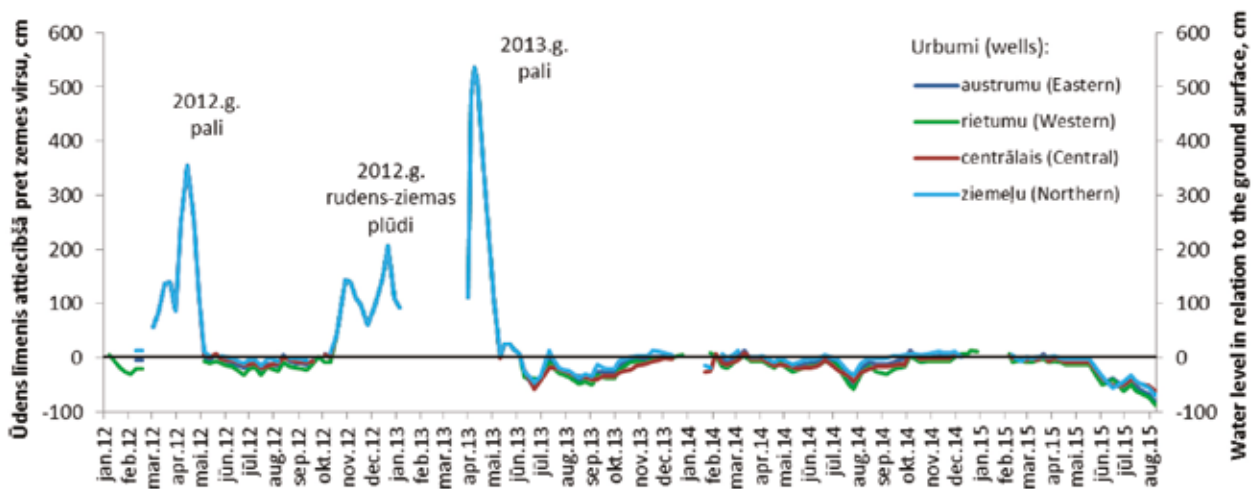
Figure 12. Changes of the relative water level at the old monitoring wells, 2012–2015 (after observations made by the author)

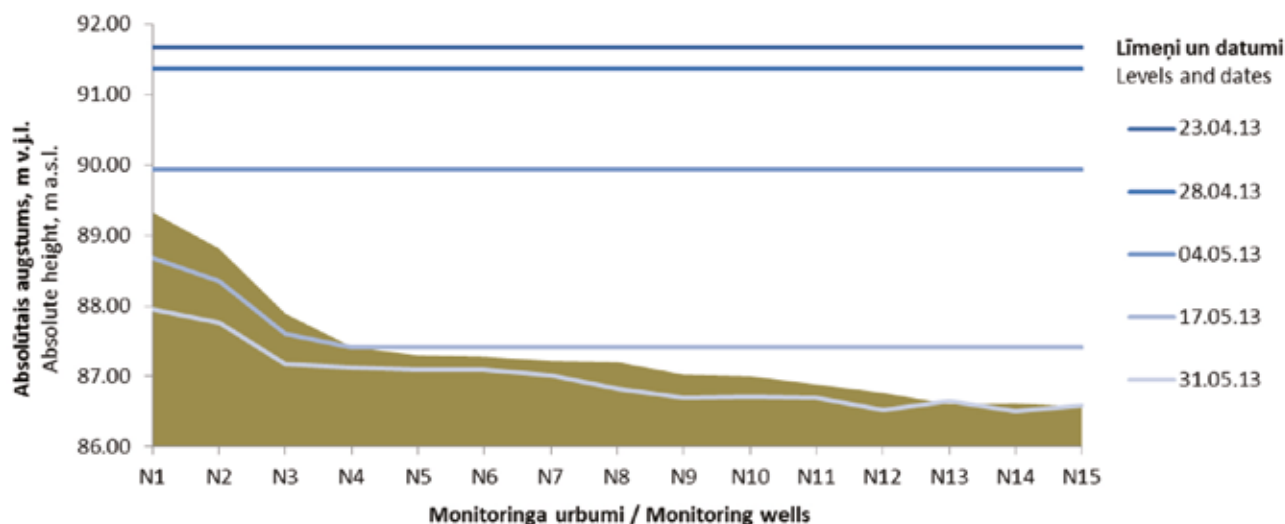
Figure 16. Water level change in the Dviete floodplain during the drainage phase of the spring floods in 2013 (according to observations made by the author and Ā. Gruberte)

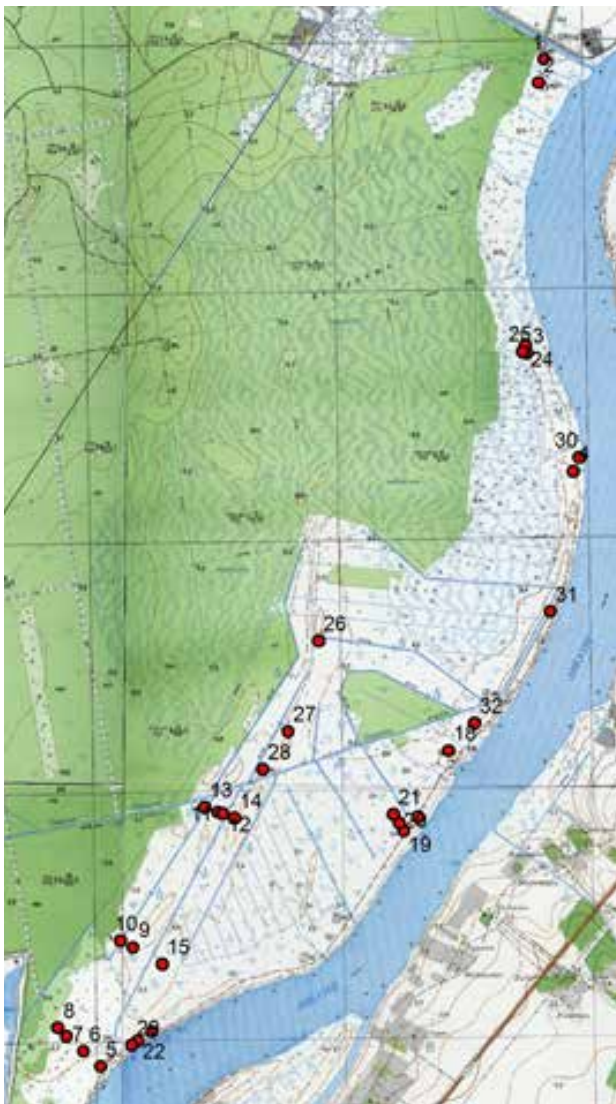
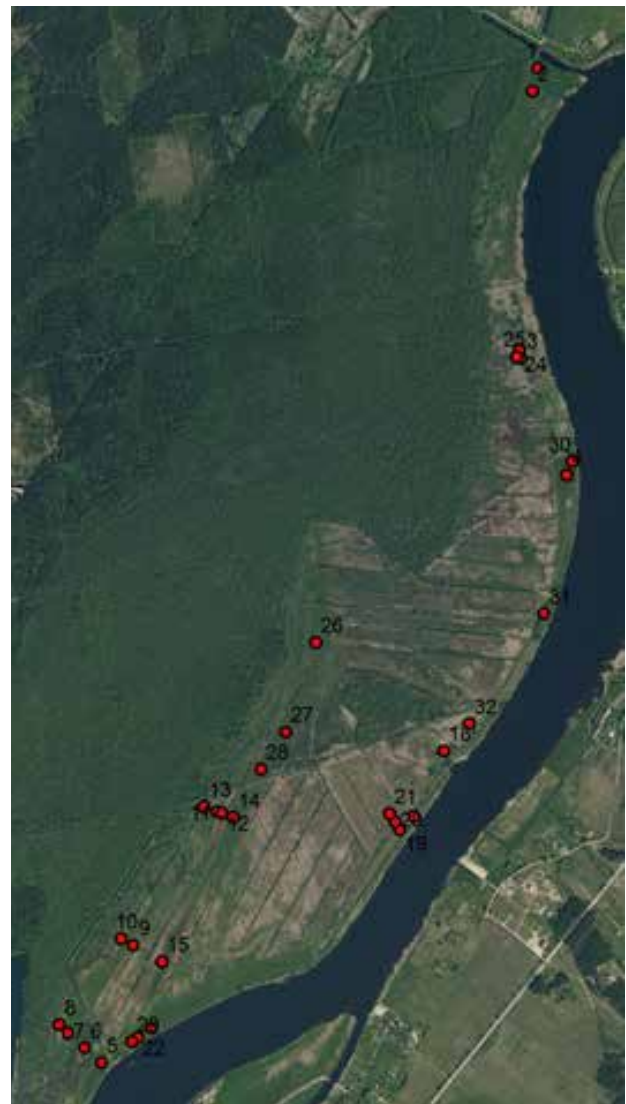
**Fig. 2.** The drainage system of the Lielupe grassland area in the 1960s (on the left) and in 2007 (on the right). The vegetation monitoring plots are marked with red dots. The background: topographic map of general headquarters of the Latvian SSR and ortho-photo map (Latvian Geospatial Information Agency).

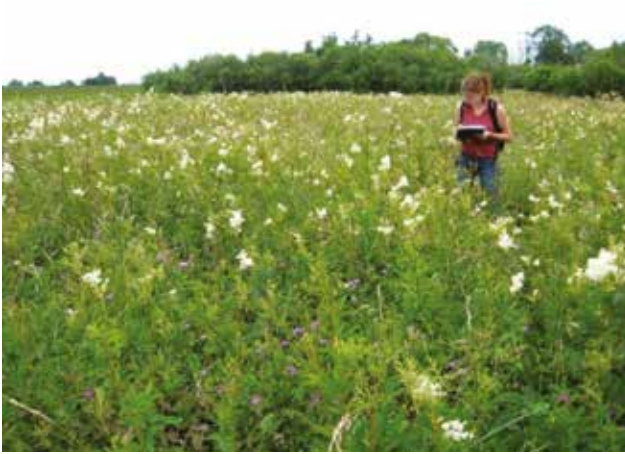
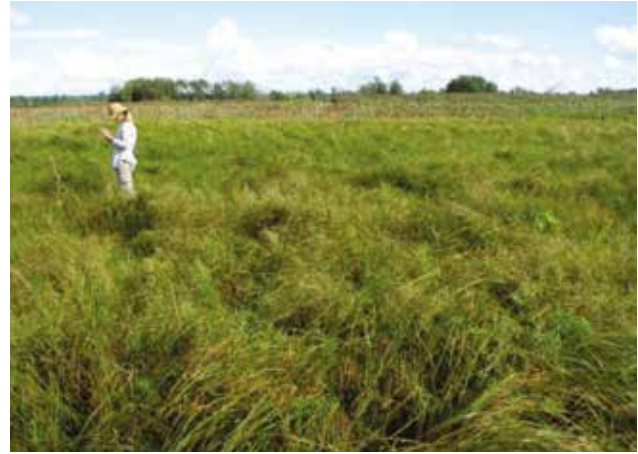
**Fig. 12.** Changes in vegetation due to paludification (example: sample plot No. 7).  
Photos: A. Liepa and A. Priede.

In the monitoring plots that are paludified due to beaver activity, the vegetation changes are quite radical. For example the vegetation in plot No 7 changed from mesophilous grassland to wet grassland, dominated by sedges, in just 2–3 years (Fig. 11 and 12).

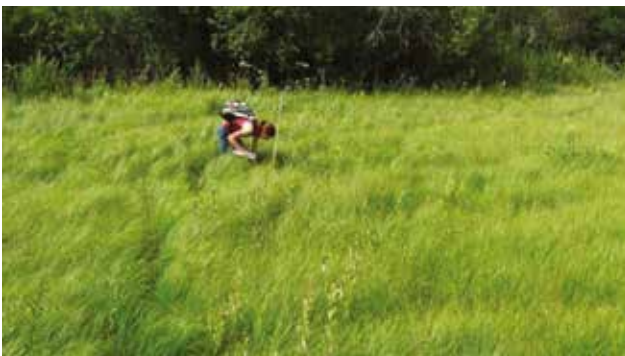
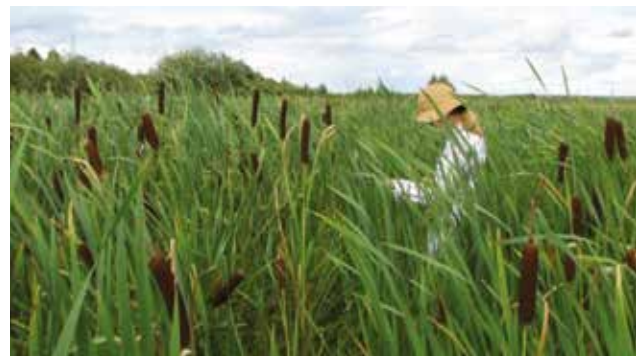
**Fig. 13.** Changes in vegetation due to paludification (example: sample plot No. 8). The tall sedge communities are being replaced by pioneer communities typical for shallow eutrophic waters. Photos: A. Liepa and A. Priede.

At the same time, in a nearby plot (No 8) wet grassland vegetation dominated by tall sedges (plot No 8) was replaced by species characteristic of paludified areas, mostly *Typha latifolia* (Fig. 13).

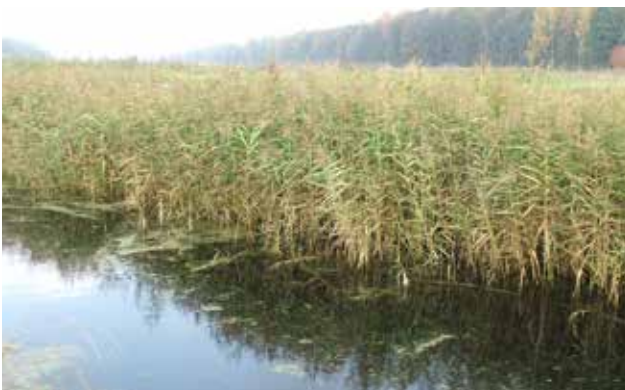
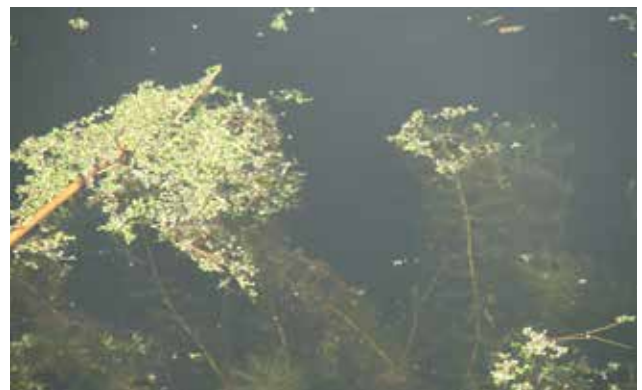
An emergent plant zone along the former regulated stretch of the Slampe stream is formed by dense *Phragmites australis* stands. Stream bed profile is trapeze-shaped with steep side slopes and water depth > 1 m.

Stands of submerged water plants in the straightened stretch of the Slampe stream is formed by *Myriophyllum spicatum* and *Lemna trisulca*. Above them, *Lemna minor* and *Spirodela polyrrhiza* forms separate patches.

**Fig. 8.** The structure of macrophyte communities in the re-meandered stretch of the Slampe stream and in the straightened stretch of the Slampe stream. Photos: L. Urtāne.

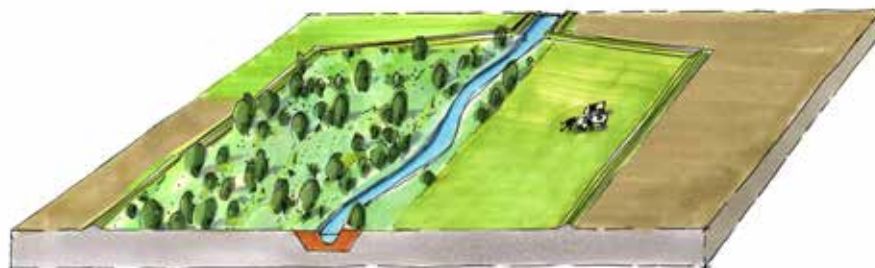
**Figure 1.** Lowered floodplain (agricultural or natural) for water retention (drawing: Dirk Oomen, Stroming BV).

In most stream restoration projects lowered floodplain areas are constructed surrounding the streams (Figure 1). Lowered floodplains typically also boost natural terrestrial floodplain processes.

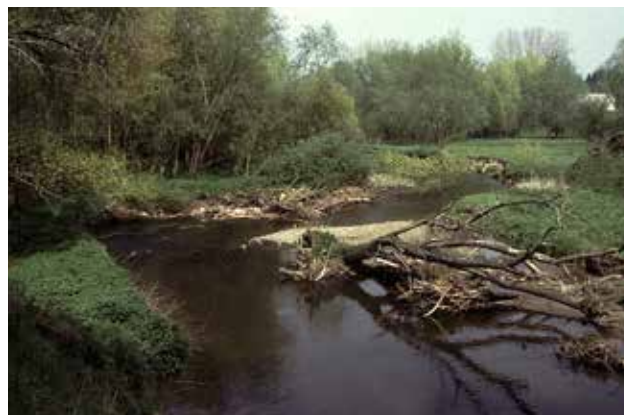
*A tree fallen into the stream forces the flow through a narrow gap between the uplifted roots and the remaining riverbank, causing quick erosion. Worm, October 2003 (photo: Willem Overmars, Stroming BV).*

Depending on the longitudinal profile, discharge and type of soil of the riverbed, a canalized stream will in time start re-meandering by itself. Obstacles in the streambed – like beaver dams and burrows, fallen trees and curves – stimulate this process. To allow this natural process to take place, artificial riverbank protection has to be removed. Burrow activities of mammals like beavers weaken the riverbank and increase erosion. In a meandering riverbed, places with fast flowing water alternate with slow flowing areas. Vegetation growing in the slow flowing areas forces the stream to curve even more and raises the water level and as a result the buffer capacity. Fallen trees play an important role in this process; to speed up meandering, trees can be placed into the riverbed.
