# RESTORATION AND MANAGEMENT OF RIVER FLOODPLAINS: EXPERIENCE OF THE LIFE+ PROJECT DVIETE

Project No LIFE09 NAT/LV/000237  
Restoration of Corncrake habitats in Dviete floodplain Natura 2000 site  
2010-2015

Publication prepared within the project LIFE09 NAT/LV/000237  
'Restoration of Corncrake habitats in Dviete floodplain Natura  
2000 site' (acronym – LIFE+ project DVIETE)

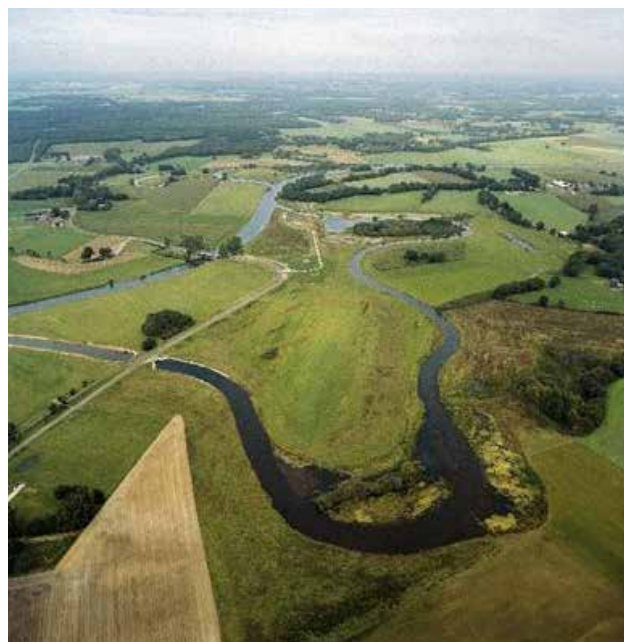
*In 2010 the old meander 'Mölnmarsch' was reconnected with the river Vecht (photo: Waterboard Vechtstromen).*

Redirecting the canalized stream into old meanders (when still present) is another way of restoration. This is realized by blocking the artificial stream; redirected flowing water will search its own path, erosion and sedimentation will soon give a natural result. To start these processes, it might be necessary to remove fresh sediment or vegetation overgrowing the historical riverbed, or even dig out the curves of the original river course. The removed material can be used to fill and block the canalized streambed and the draining ditches in the floodplain. To maximize ground water level rise, the artificial channel should be blocked on both ends.

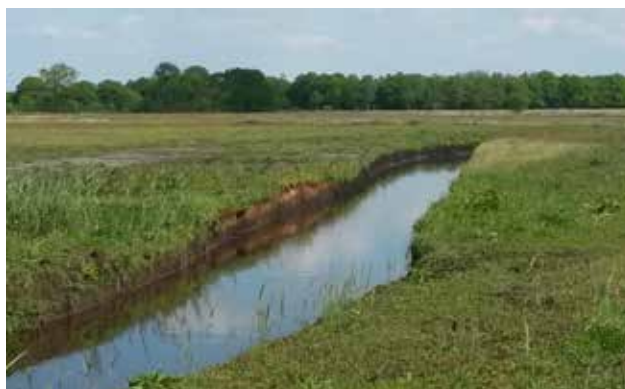
New river bed guided by low areas in the floodplain. Peizerdiep, 2014 (photo: Bart Reeze, Stroming BV).

Restoration measures, taken in a certain river-stretch of stream, need to comply with the physical situation. When the balance tends to bend to the right, restoration measures need to focus on the right dimensions of the bed (corresponding a bank full discharge occurring once in 1.5–2 years), as well as to the prevention of vegetation growth by reducing nutrient levels and/or creating adjacent tree zones in order to reduce the amount of light falling onto the water. When the balance tends to the left the stream power is too small to prevent vegetation overgrowing the bed and the situation will tend to a swamp. In order to enable vegetation growth and keep maintenance activities on a minimum in this swampy situation, the dimensions of the bed should be larger and shallower.

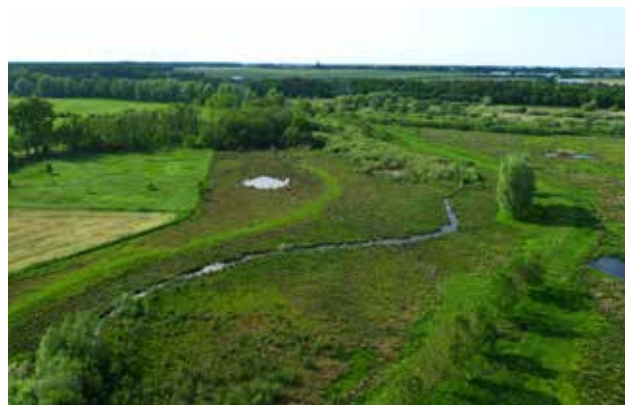
Aerial view of the Roode Beek in 2012, 10 years after the restoration (photo: Dirk Oomen, Stroming BV).

In the Netherlands there is a lot of experience with restoration of rivers and smaller streams. Since the 1990's, especially in the eastern and southern part of the country the water boards have restored natural courses of hundreds of smaller streams. In most cases the old bed was no longer visible and new bed had to be created. An example of this type of restoration is the Roode Beek near Schinveld in the province of Limburg (Figure 3). To activate natural processes a broad shallow bed was excavated with enough room for the stream to shape its own path.

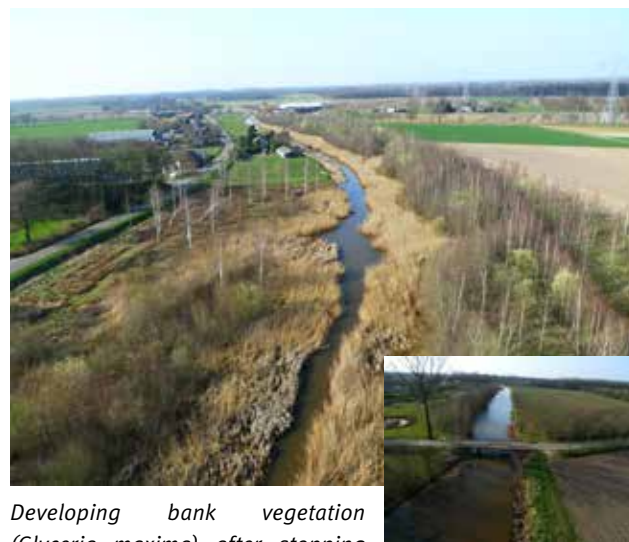
Developing bank vegetation (*Glyceria maxima*) after stopping maintenance. Lage Raam, 2013. At the bottom right the same stream at a section with normal maintenance (photos: Dirk Oomen, Stroming BV).

Another example of stream restoration without engineering can be found in the Lage Raam. In this lowland stream (slope < 1 m/km) maintenance stopped

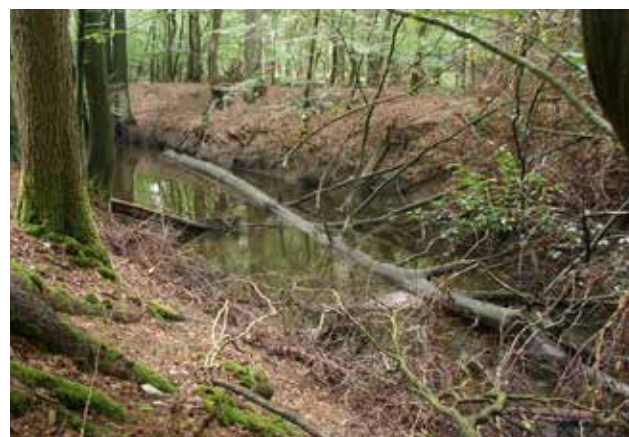
Introduction of stems in the Hierdense beek (photo: Bart Reeze, Stroming BV).

More recently, tests were done with (tree) stems in a number of streams in the Netherlands, e.g. Hierdense Beek, Tongelreep and Jufferbeek. A protocol was set up to optimise ecological effects and to keep backwater effects limited. Per location a couple of trees crossing each other were lowered into the stream, covering the whole width and 10–20 meters length of the stream. The results are promising: an increase of habitat and stream fauna diversity was observed while backwater effects were limited. However, in agricultural areas without tree cover and higher nutrient levels the location might become overgrown by aquatic macrophytes and bank vegetation.

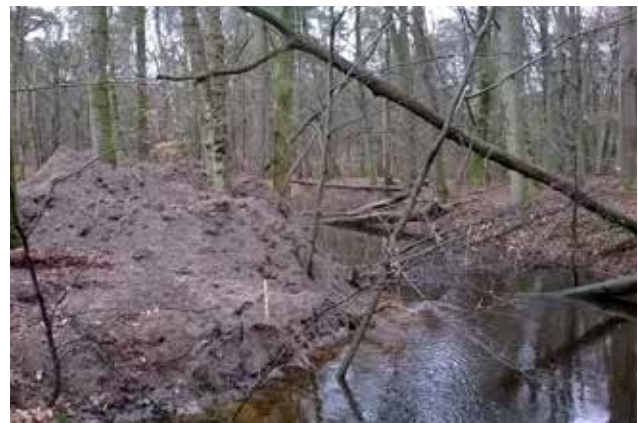
*River bed elevation by slowly pushing sand into to the stream, letting the 'water do the work'. Hierdense beek, 2014 (photo: Bart Reeze, Stroming BV).*
